NEARSHORE CURRENTS AND CORAL REEF  
ECOLOGY OF THE WEST COAST OF GUAM,  
MARIANA ISLANDS

3. REPORT TITLE  NEARSHORE CURRENTS AND CORAL REEF ECOLOGY OF THE WEST COAST OF GUAM, MARIANA ISLANDS			
4. DESCRIPTIVE NOTES (Type of report and inclusive dates) Technical Report. 4 Feb. - 3 Mar. 1971 and 19 Aug. - 15 Sept. 1971

SPECIAL PUBLICATION

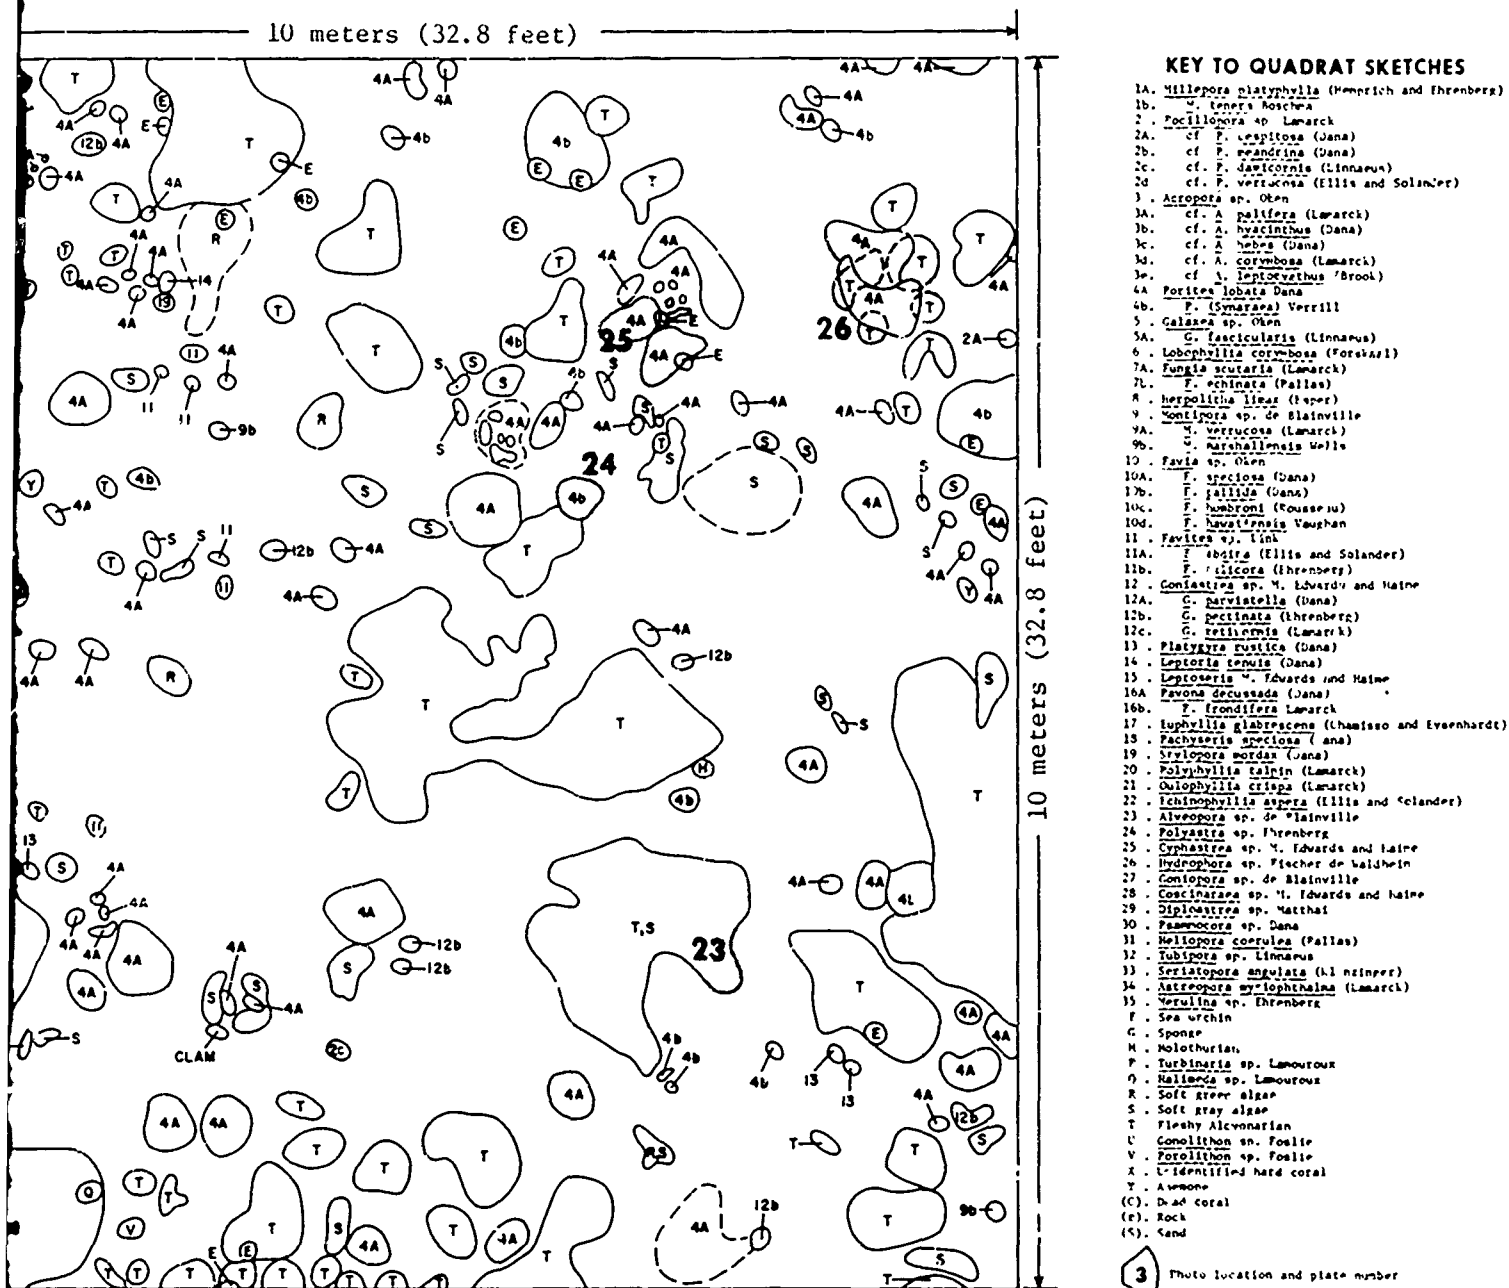
Figure 132. Species distribution chart, quadrat 7, Piti Bay.

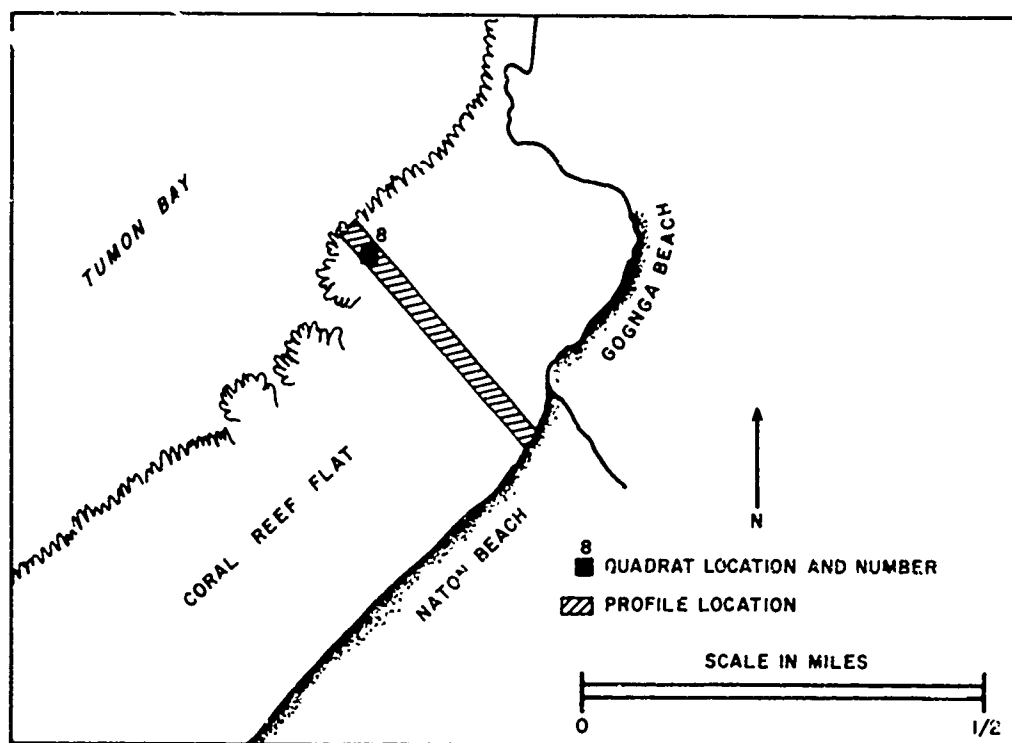
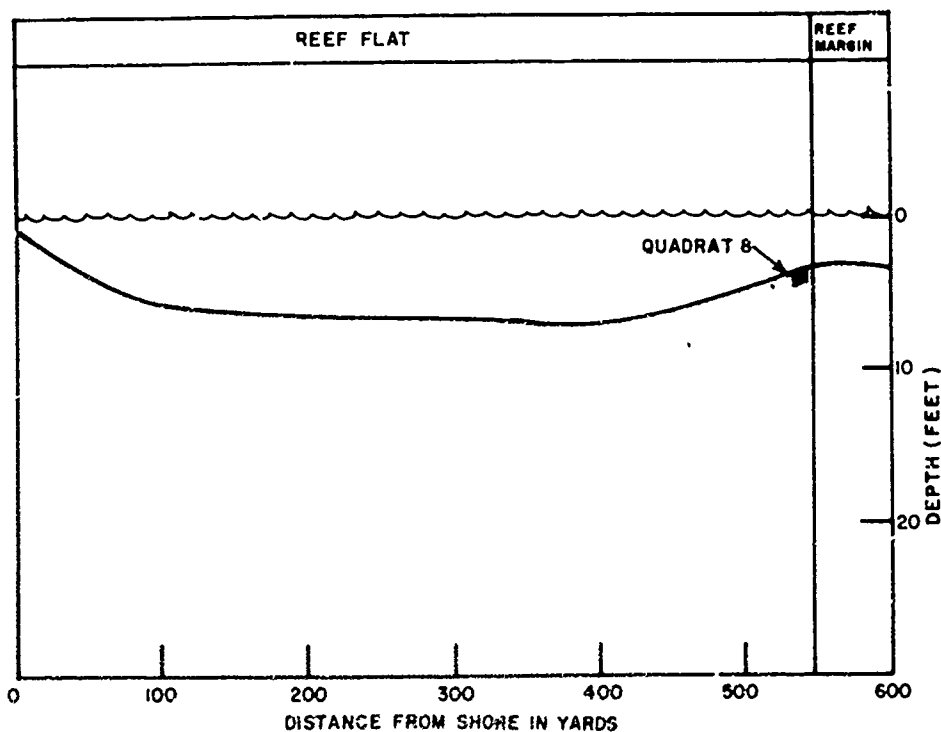
Figure 134. Area chart and reef profile for Tumon Bay ecological study.
